**ICEM07-7219**

**ALPHA-CONTAMINATED SOLID WASTE SORTING AND CONDITIONING AT BELGOPROCESS  
(BELGIUM): LESSONS LEARNED FROM THE FIRST THREE YEARS OPERATION**

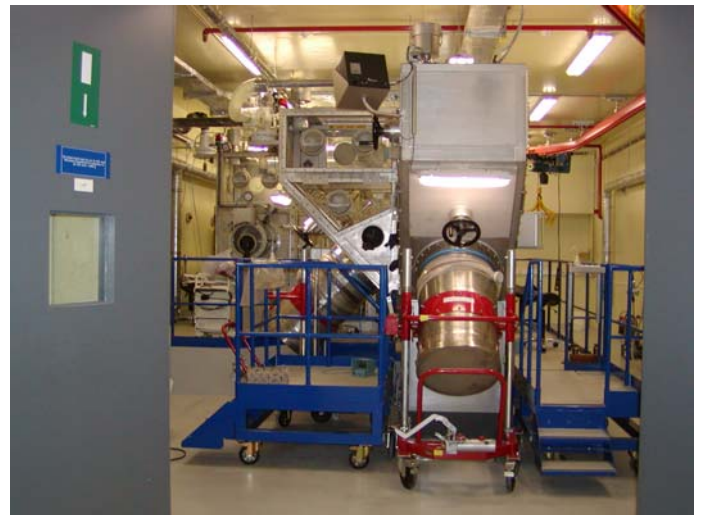
Figure 3: view at HK6

In HK6, the A3X packets are weighed, characterized chemically and physically by visual inspection, then set into the A31 ALDRUM for the burnable and into the A34 ALDRUM for the non burnable.

Figure 3 is a photo of the sorting facility, view at HK6.

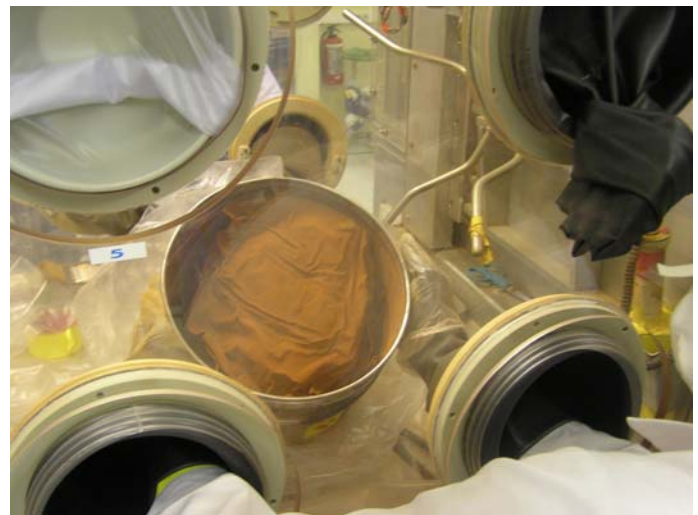
Figure 4: rust in 30-l can

Manny 30-l cans were corroded, varying from small rust spots over the inside of the can that was totally affected by corrosion, which left the waste and bottom covered in a relative thick layer of dust, to cans with holes up to several centimetres in diameter. Cans with externally visible faults were already put into a plastic bag before shipment to the sorting facility.

Figure 4 shows the inside of a 30-l can with rust covered waste packets

The powdery rust was problematic, as it spread over HK1 and HK2. The position of the ventilation inlets was adapted, the

point of extraction was brought down to the vicinity of the bottom of the glove box. This meant not only a smaller dispersion of rust but also of contamination in HK1.

Radiolysis of PVC forms hydrochloric acid, this could explain the fact that corrosion developed from within the cans. We had the impressions that cans were more corroded if they had packets containing MOX-powder in direct contact with allot of PVC .
